BLM hardware changes in SPS during LS2

BE-BI-BL

Ewald Effinger for the BL section

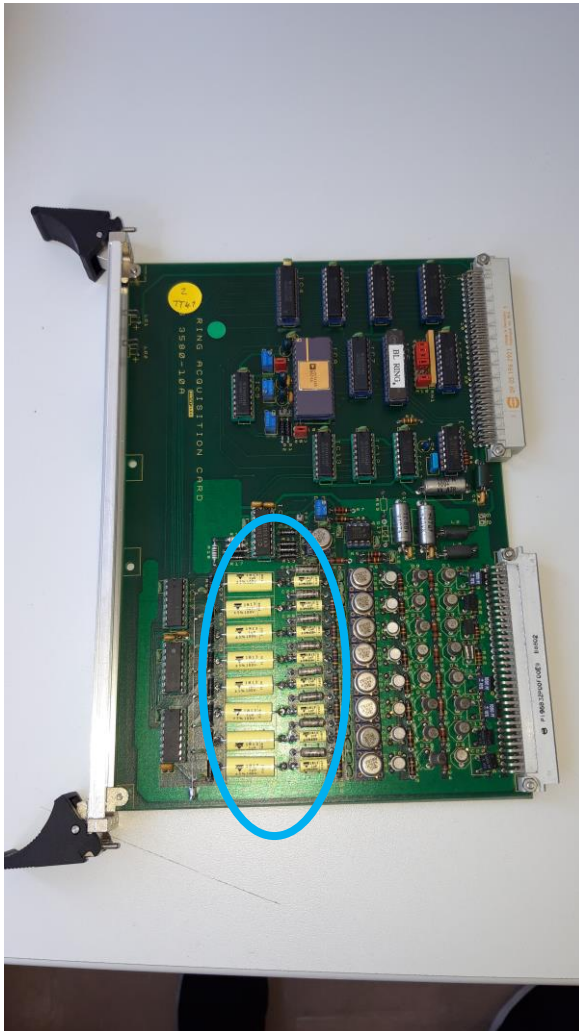
Changes on the Integrator card (Integrator)

Exchange of the all capacitors of the integrator, due to aging capacitors and combinations variety.

- Existing combinations, gain ratio and resulting error in respect to software ratio 200

• 5.1nF/1uF	-> Gain ratio = 196	(-2%)
• 4.7nF/1uF	-> Gain ratio = 213	(+6.5%)
• 33nF/4.7uF	-> Gain ratio = 142	(-29%)
• 5.1nF/9.4uF	-> Gain ratio = 1843	(+817%)
• 33nF/9.4uF	-> Gain ratio = 285	(+42.5%)
• 38nF/9.4uF	-> Gain ratio = 247	(+23.4%)

- Future: two combinations and software ratio:

• 1nF / 1uF	-> Gain ratio = 1000	(0%)
• 10nF / 10uF	-> Gain ratio = 1000	(0%)

- Combination reduced from 6 to 2 types
 - improvement of spare situation
