TDIS impedance measurements

Sébastien Joly

01/10/2020

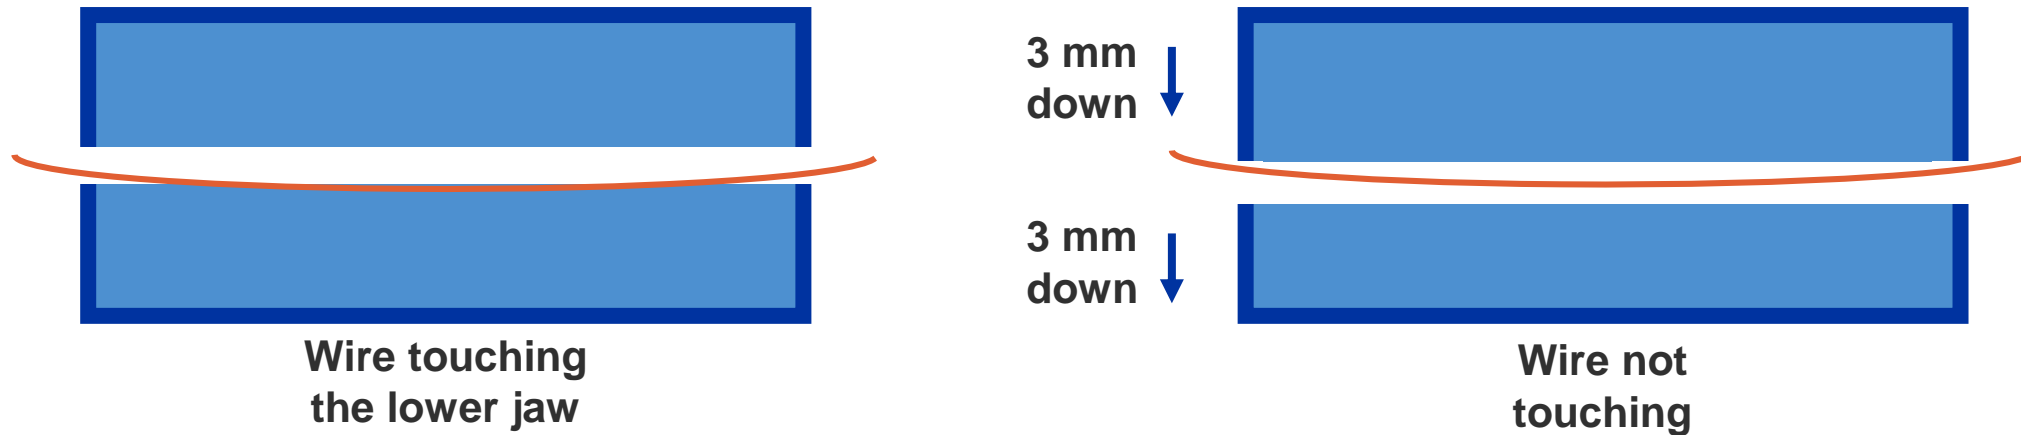
For this gap we had to slightly change the jaws position.

When we moved to the 6 mm half gap with the previous configuration, the wire was already touching one of (or several) jaw(s).

We translated upper and lower jaws 3 mm down in order to avoid the wire touching.

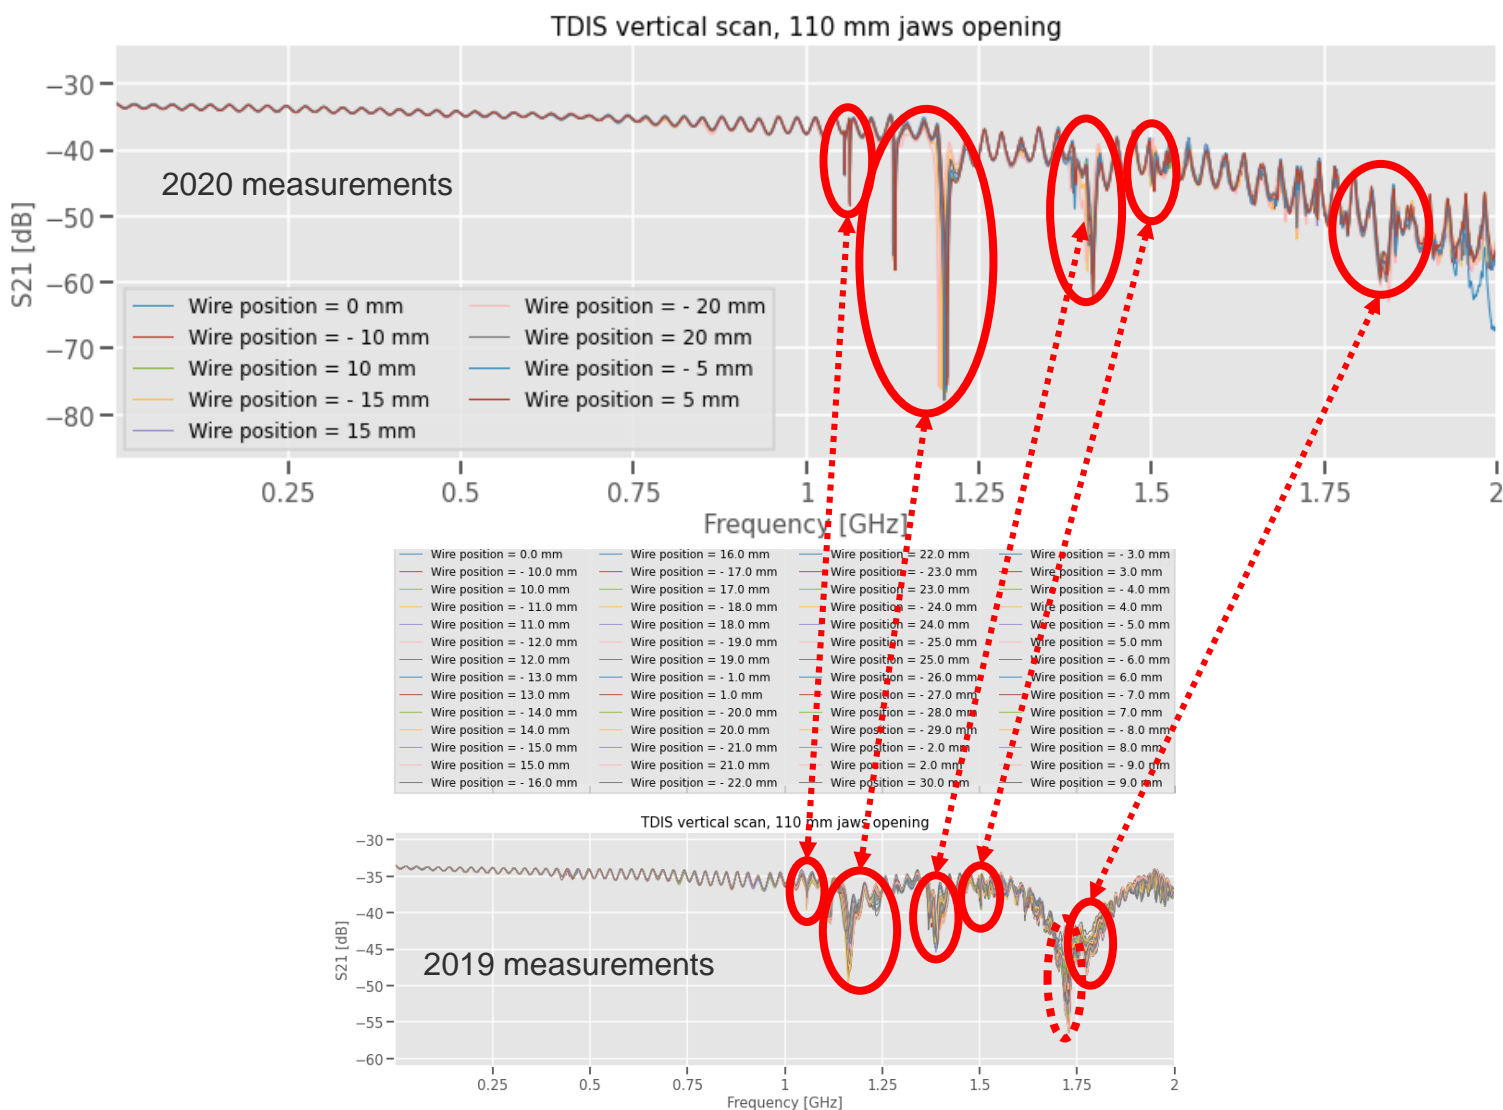
Vertical scan, 110 mm full gap

We find a good agreement between the previous and current measurements.

We are able to find the same modes at approximately the same frequencies.

No significant mode is visible below 1 GHz.

The mode at 1.75 Ghz (dashed line) is not visible on the 2020 measurements.

We are able to spot a couple of sharp modes in 2020 measurements that were not seen during 2019 measurements.

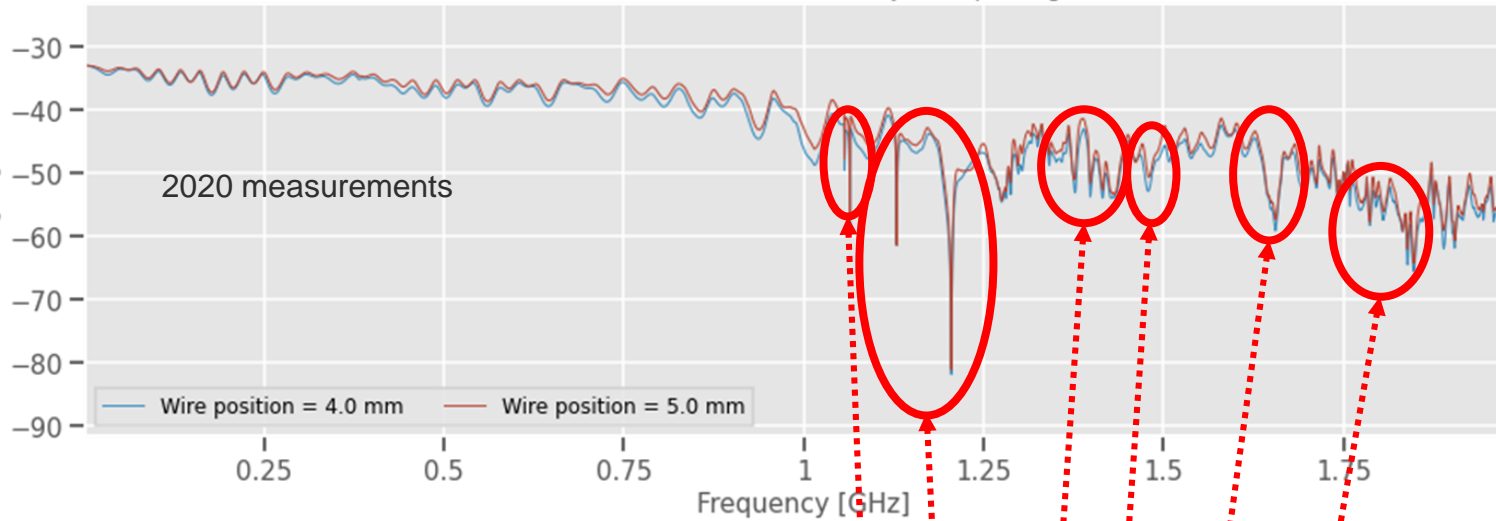
TDIS vertical scan, 12 mm jaws opening

Again we find a good agreement between the previous and current measurements.

The baseline seems to be moving much more in 2019 than in 2020 (could be explained by the different setup ?).

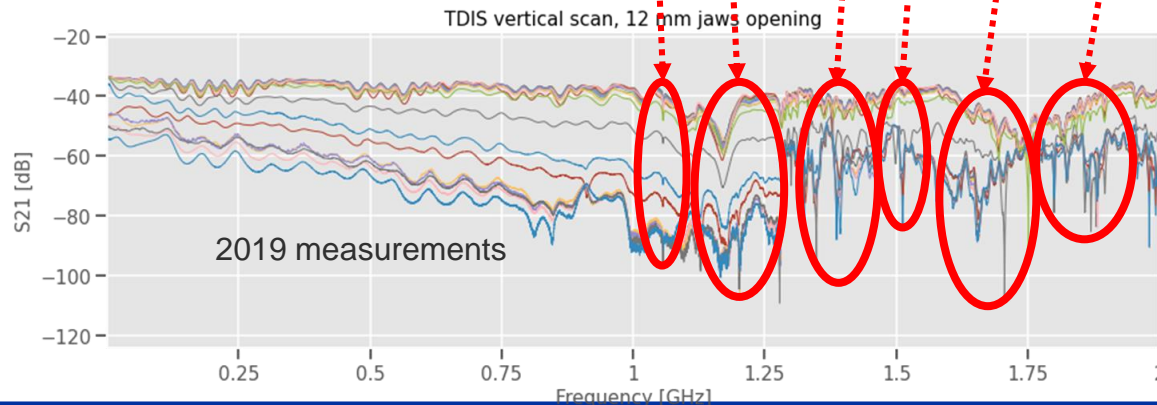
The mode at 1.75 GHz seems to have disappeared on 2019's measurements plot.

When closing the jaws, a new mode starts to appear at ~1.6 GHz. However it is visible on both sets of measurements.

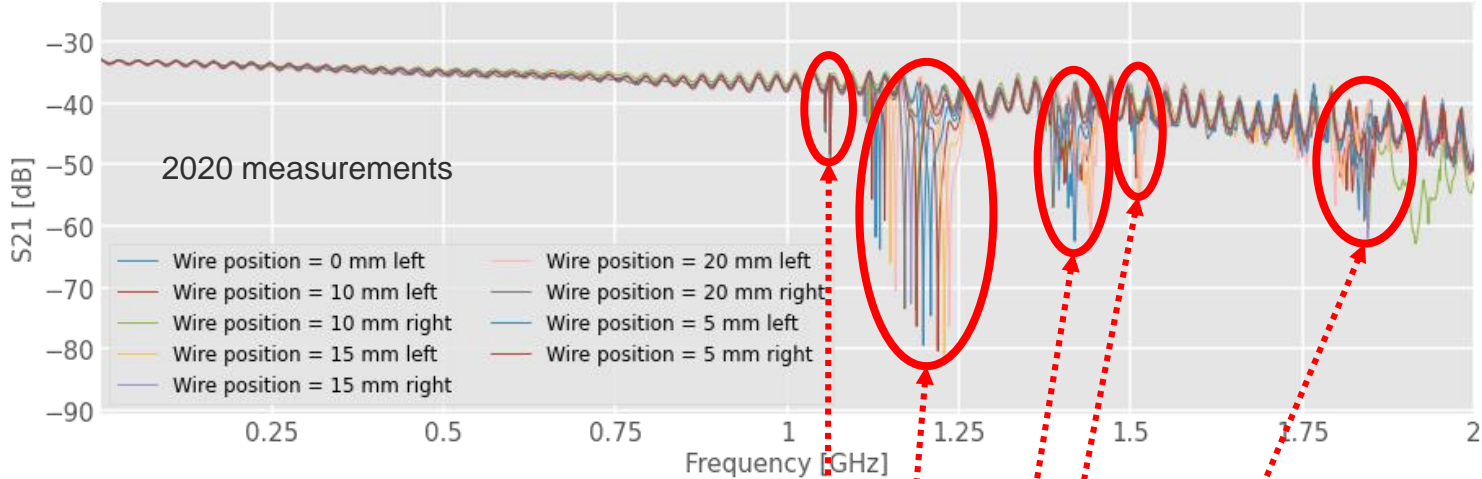
TDIS horizontal scan, 110 mm jaws opening

We find a good agreement between the previous and current measurements.

We are able to find the same modes at approximately the same frequencies.

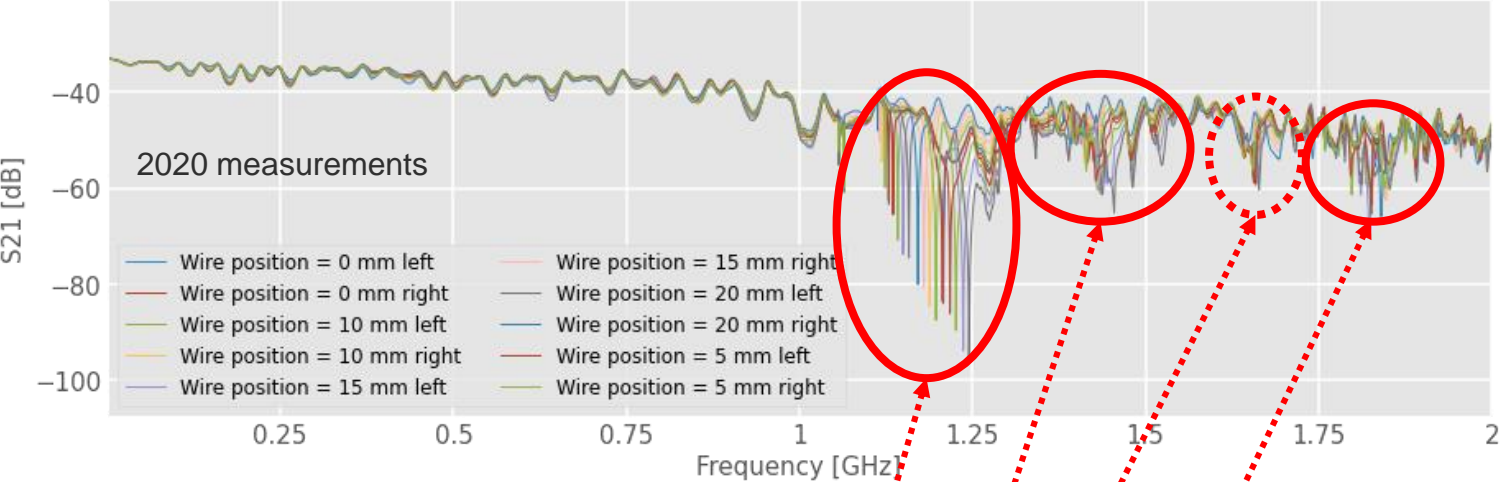
TDIS horizontal scan, 12 mm jaws opening

Again we find a good agreement between the previous and current measurements.

Again few modes seem sharper in 2020 measurements than during 2019 measurements.

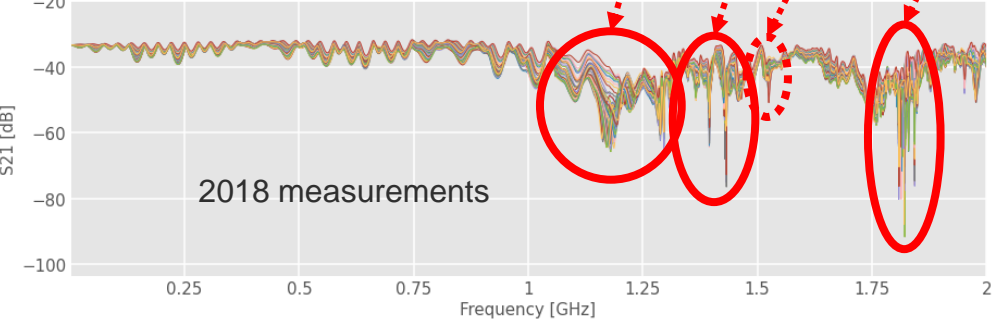
TDIS horizontal scan, 12 mm jaws opening

When closing the jaws, a new mode starts to appear at ~1.6 GHz. However it is visible on both sets of measurements.

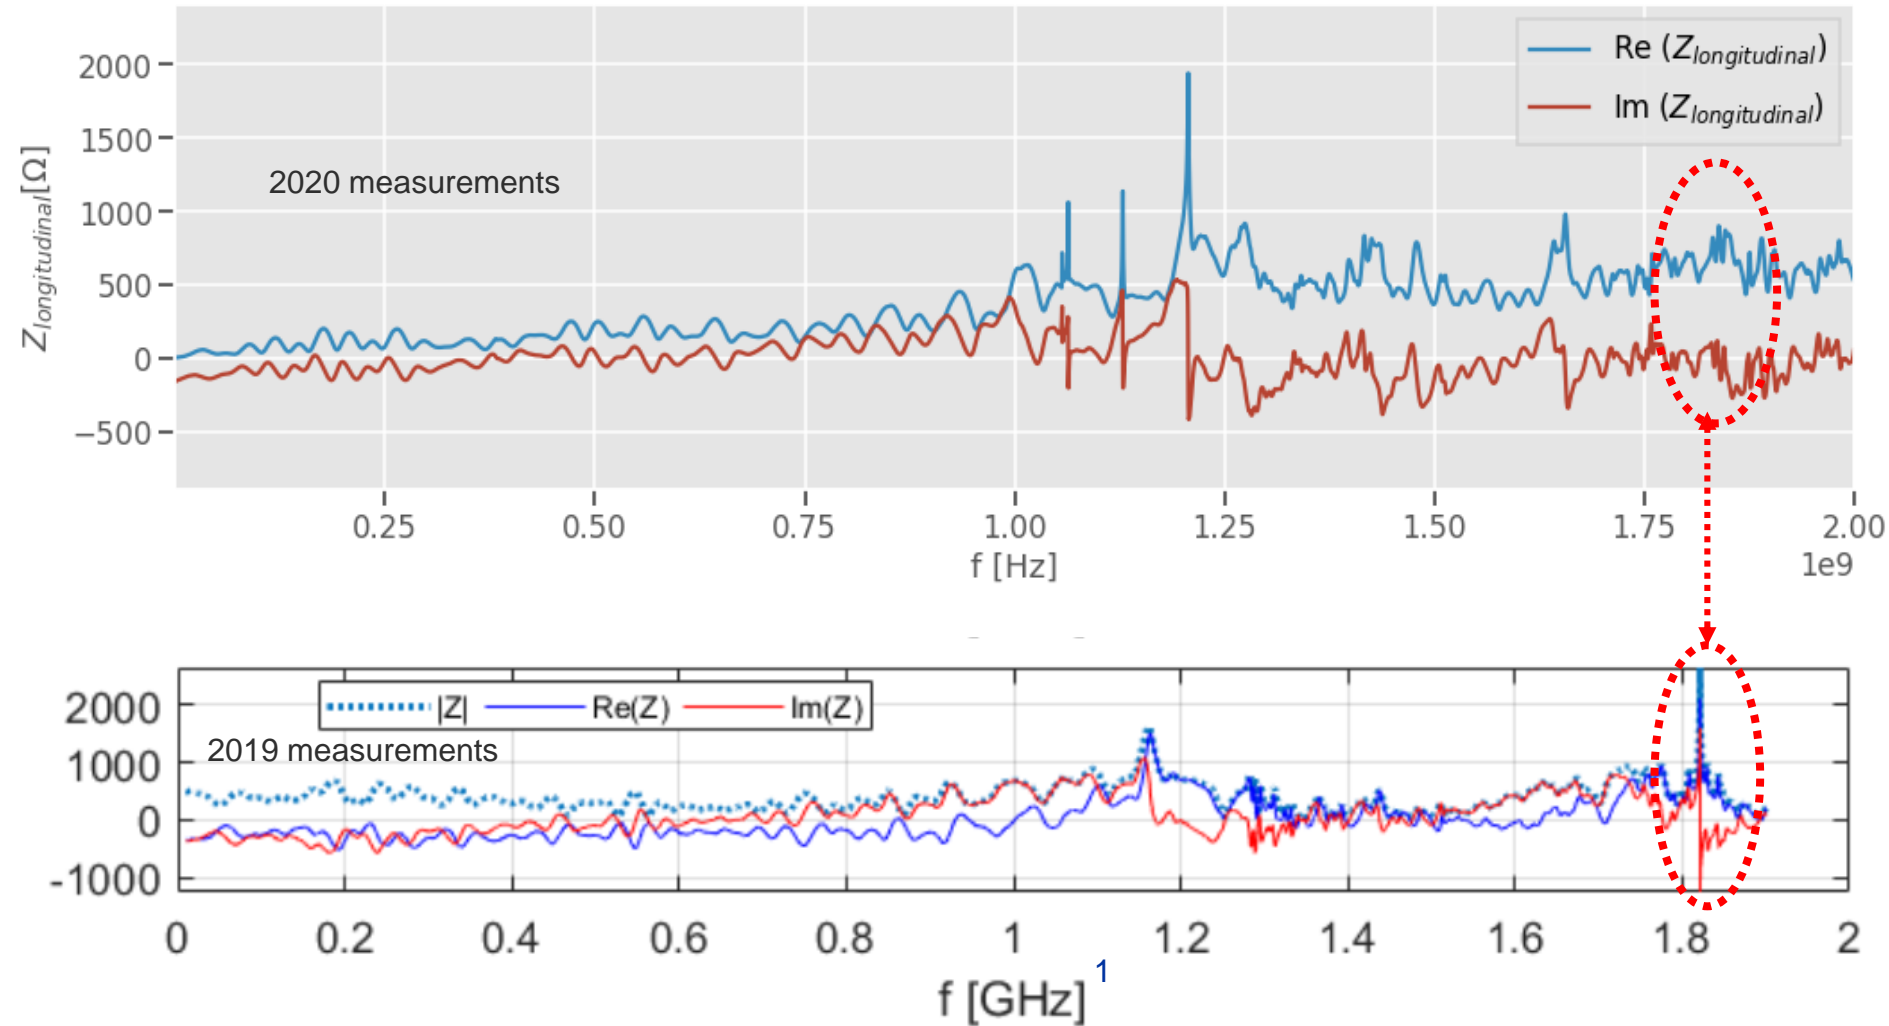
Horizontal scan, 12 mm full gap

Post-processing done according to Kroyer et al. using the improved log formula.

When plotting the longitudinal impedance we observe similar curves of the same order of magnitude.

It is worth mentioning that we are not able to spot the narrow mode (dashed line) at 1.8 GHz during the 2020 measurements.

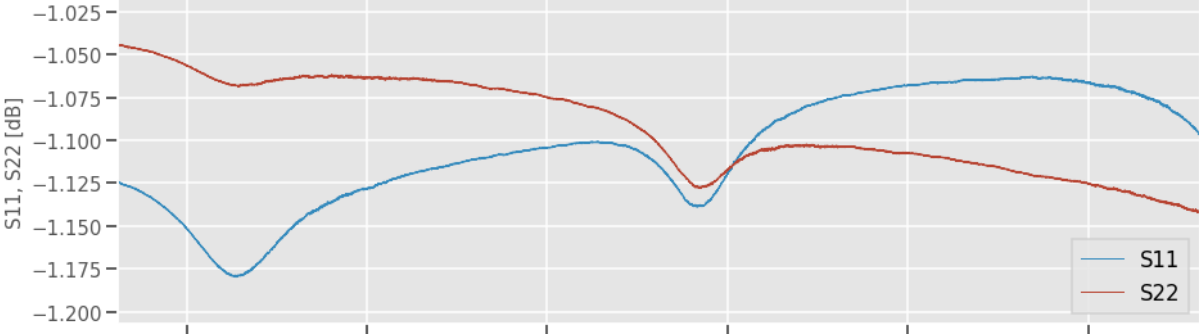
Probes measurements, 110 mm jaws opening

800 MHz mode (which was visible at 890 MHz during last measurements) can be seen around 895 MHz with fully open jaws.

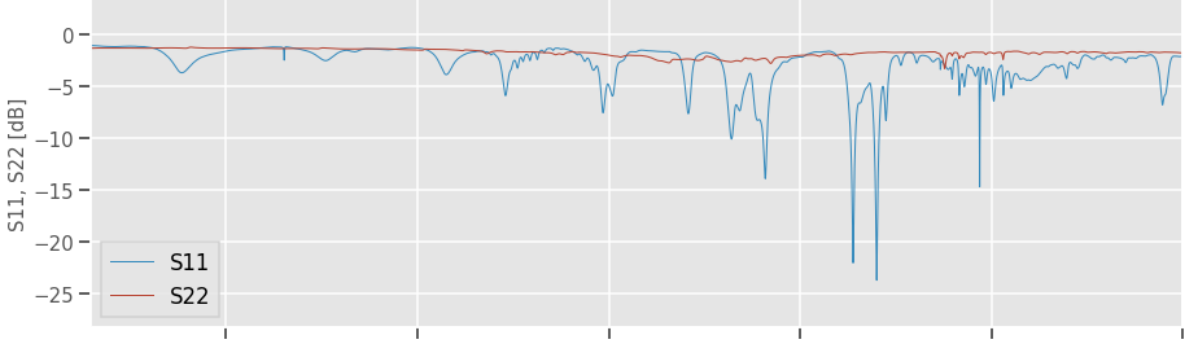
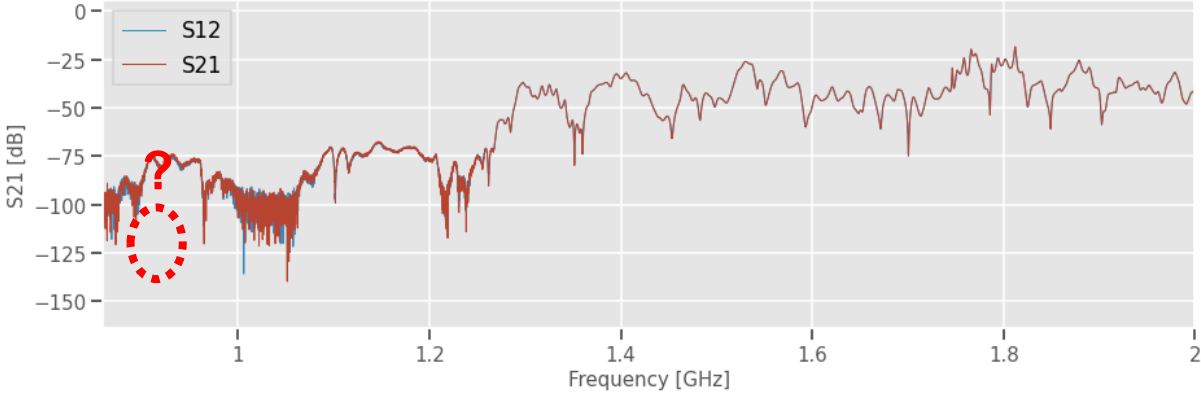
Probes measurements, 12 mm jaws opening

However we didn't manage to find it back when moving to the 12 mm full gap.
