Experience with 175MHz, 200kW, CW couplers for LIPAc's RFQ

DE FRANCO Andrea, CISMONDI Fabio
on behalf of the IFMIF/EVEDA Integrated Project Team
6th WWFPC; 2nd - 3rd July 2024 - CERN

Linear IFMIF Prototype Accelerator (LIPAc)
Rokkasho Fusion Institute (BA Site)

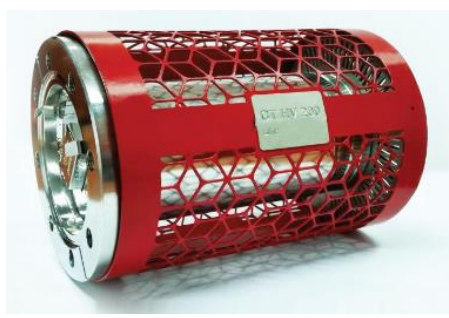
Slits machined directly into the lid.
 Follow current direction & larger aperture.
Vacuum pumps:
 Add port for
 1 NEG (200 L/s SAES CapaciTorr HV200)

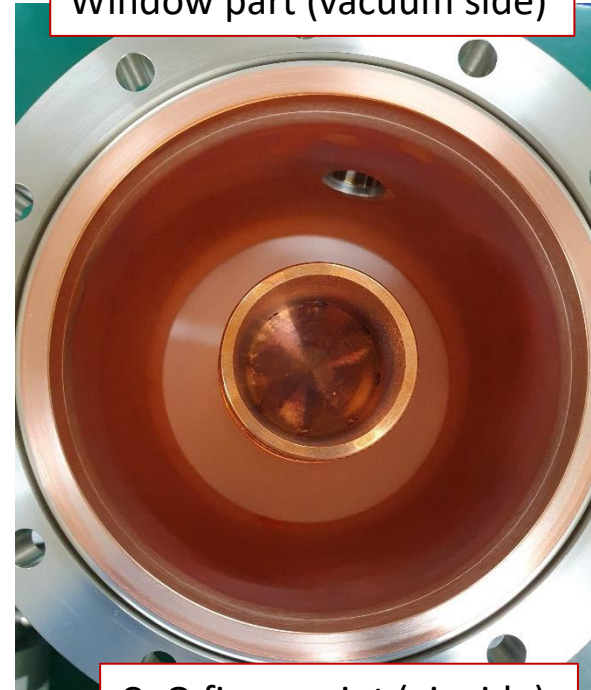
Antenna part

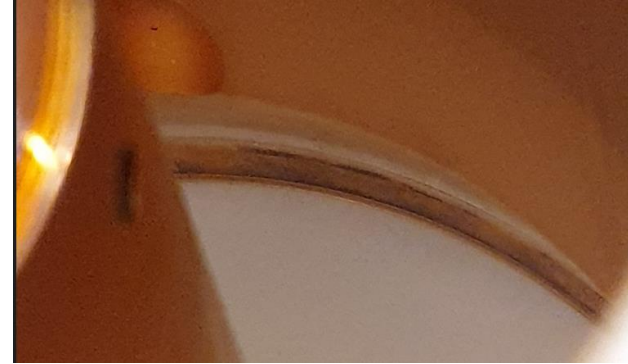
Significant oxidation marks On straight near antenna

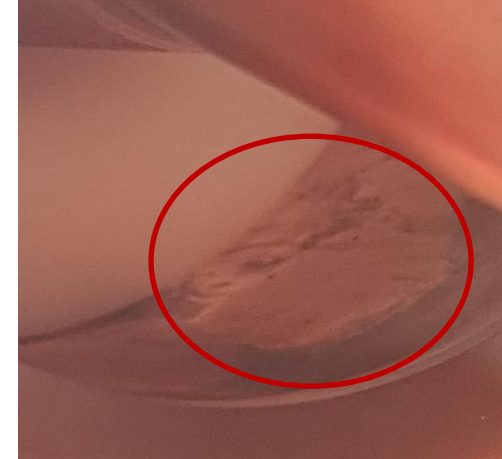
CuO fingerprint (air side)

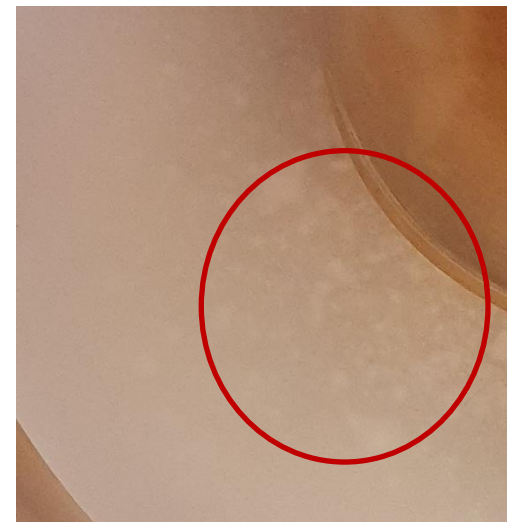
Severe loss of Cu near vacuum port. Edges are sharp...

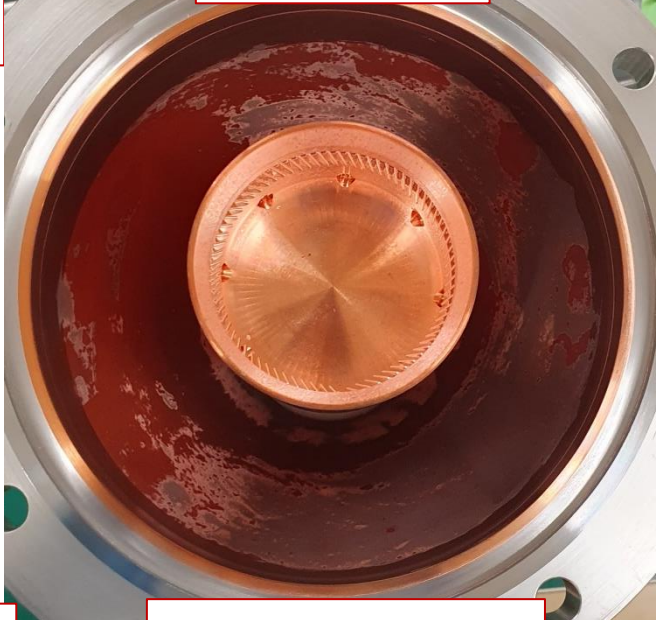
Discoloration (SUS? Oxide?) on
the outer conductor

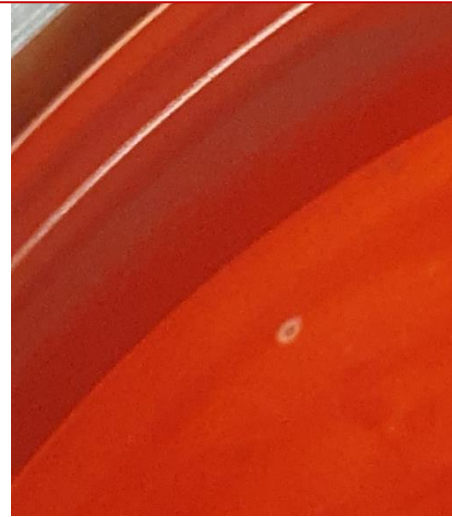
Minor arc – Ceramic

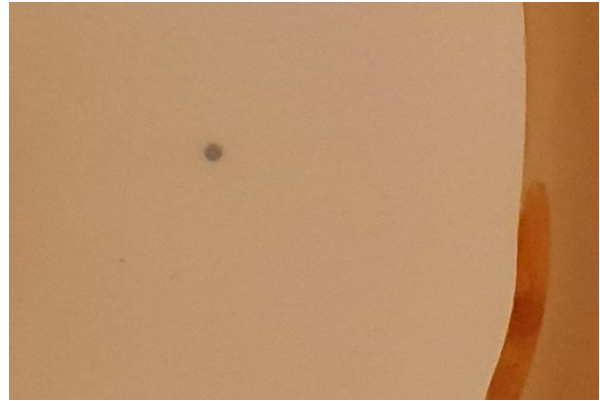
Marks near vacuum orifice

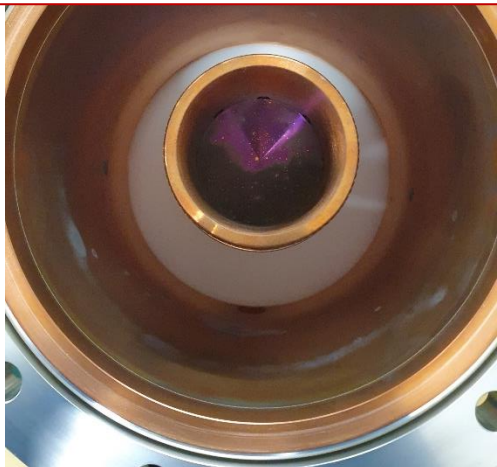
Marks on outer cond. – heat inside inner cond.
Power test without cooling?

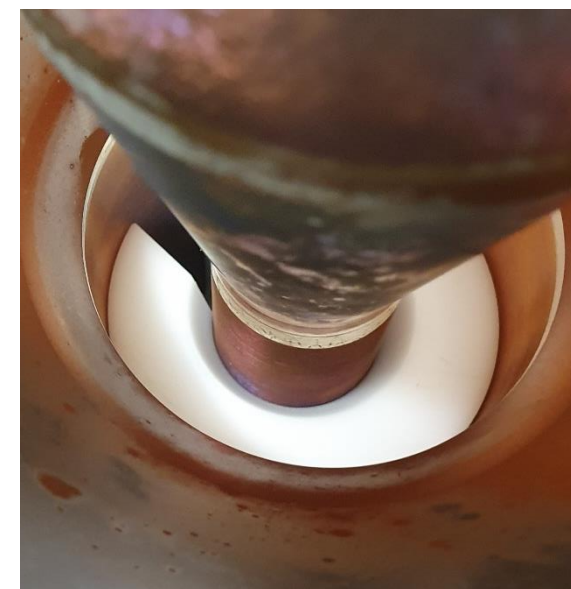
Marks on outer cond. – heat inside inner cond.

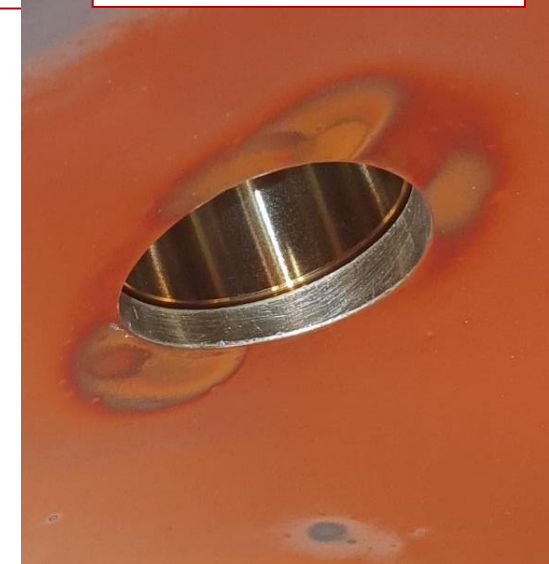
A bit of CuO (air)

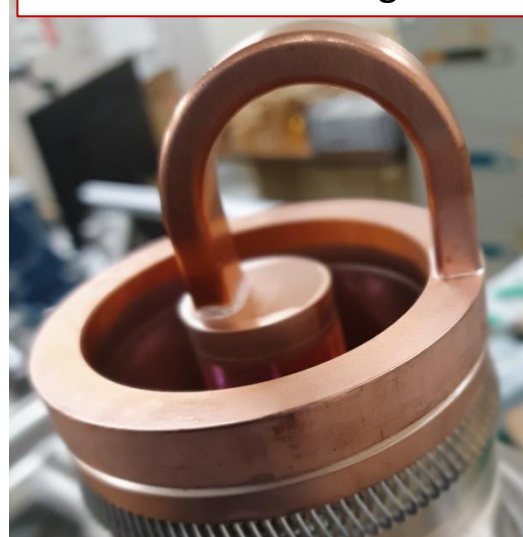
Inner looks bad (similar bands)

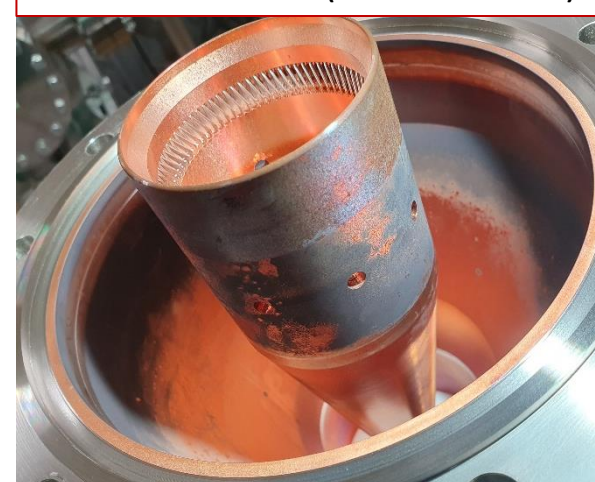
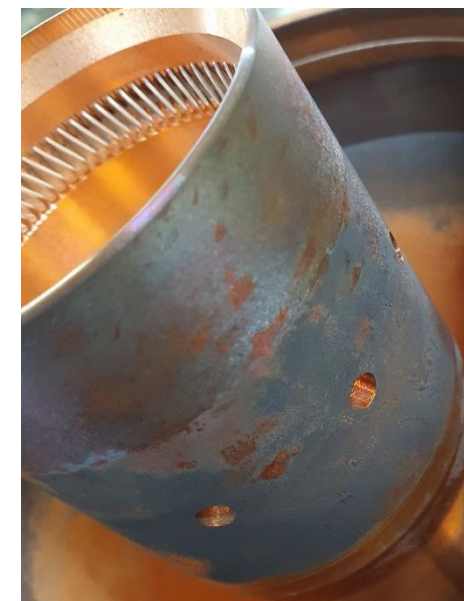
Some sparks / minor discoloration band on outer cond.

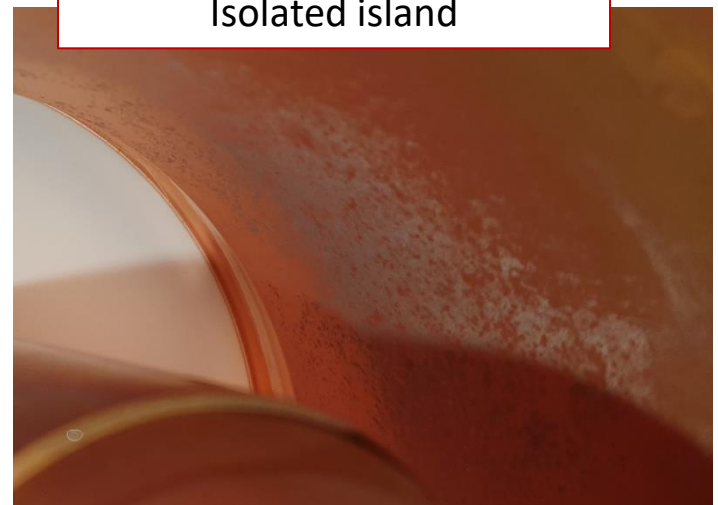
A bit of CuO (cooling line)

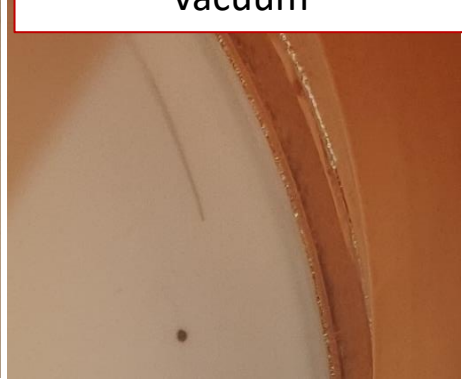
Major oxide (also near brazing)

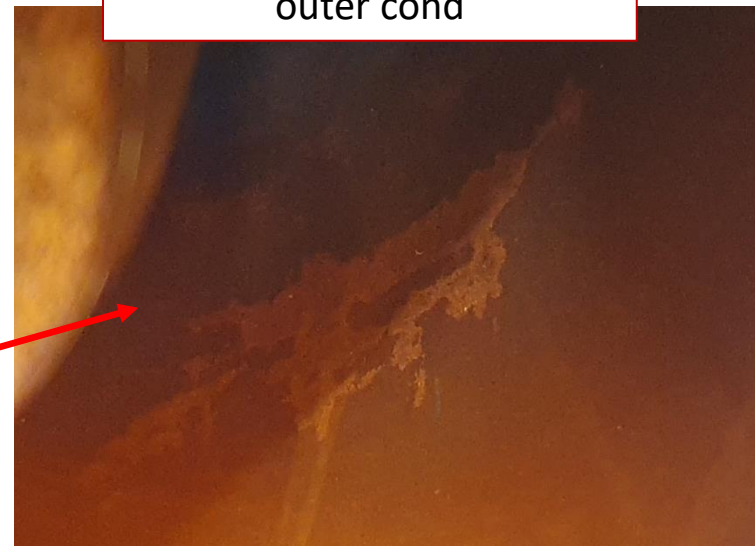
A bit of CuO (air side)

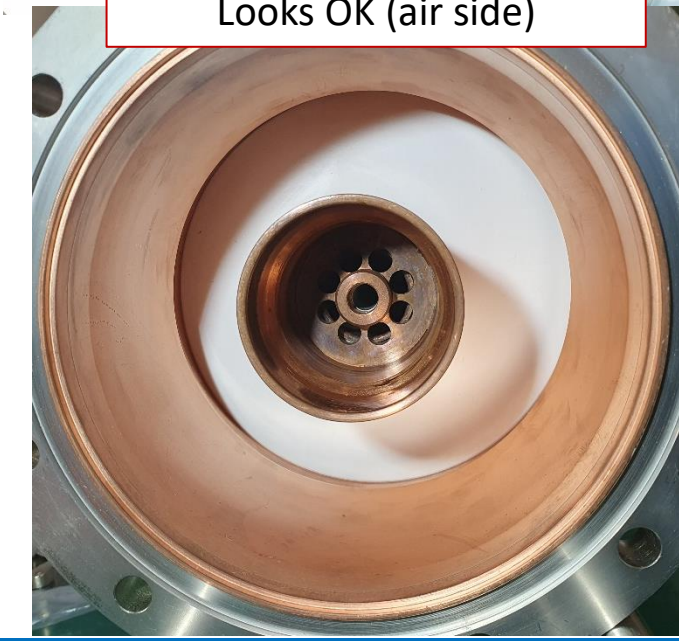
Antenna looks OK

Marks on outer in a band
