Soldering tests of quench heaters (QH) Computed tomography (CT) imaging and metallurgical investigations

Mariusz Jedrychowski - Mickaël Crouvizier – Mickaël Meyer/Mechanical & Materials Engineering group, EN-MME-MM

Post-mortem analysis CR14

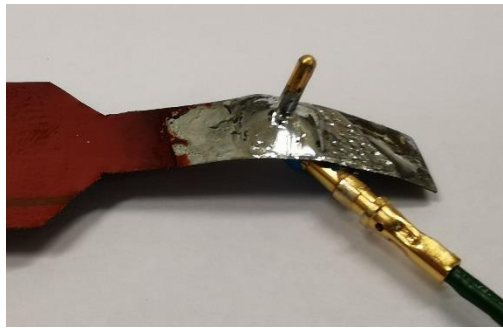
ENS-AE-DP : Tinning, Pickling

Reduced soldered interface due to embedded QH (arrows) and big void (CT scan).

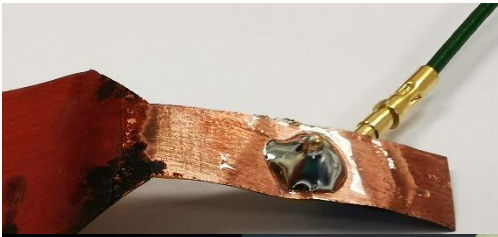
ENS-SE-DP : Pickling (partial)

Partial bonding due to the presence of polyimide film, large void under the solder.

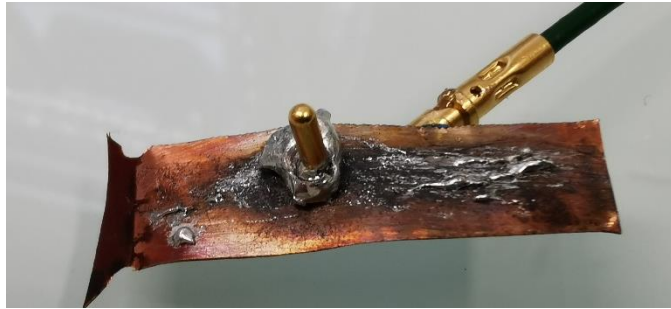
ENS-AE : Tinning

Solder is detached from QH copper tape.

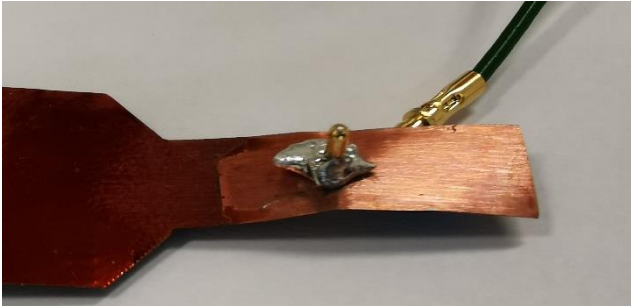
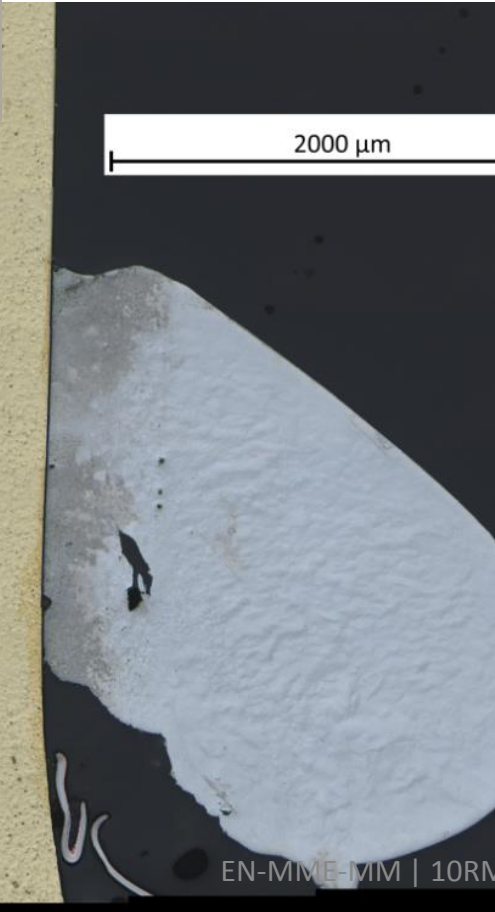
ENS-SE :without any preparation

Poor joint quality, the pin's connector is not soldered to QH copper tape

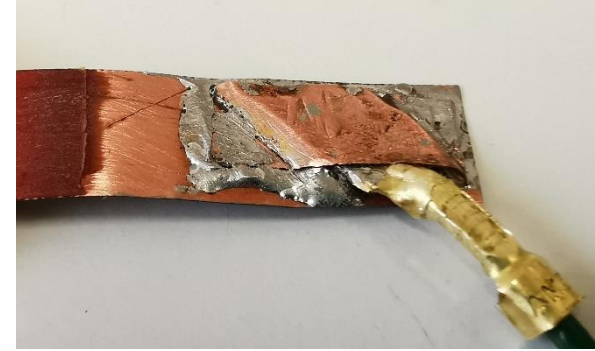
interface between the connector and the solder

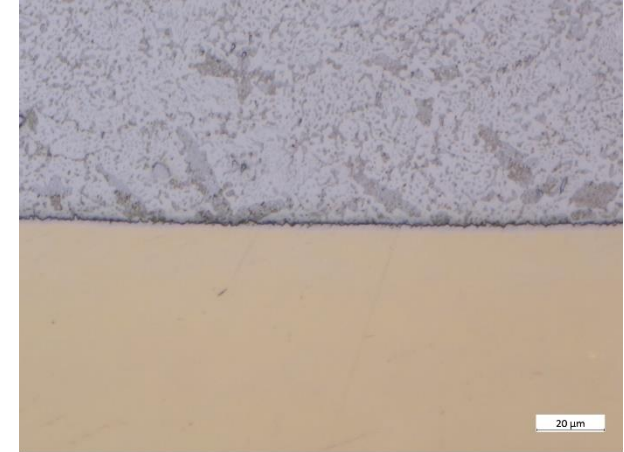
interface between the connector and the QH
